DEPARTMENT OF TRANSPORTATION**DIVISION OF ENGINEERING SERVICES**

Contract #: 04-0120F4Cty: SF/ALA Rte: 80 PM: 13.2/13.9File #: 69.28**WELDING INSPECTION REPORT****Resident Engineer:** Pursell, Gary**Address:** 333 Burma Road**City:** Oakland, CA 94607**Report No:** WIR-004688**Date Inspected:** 11-Nov-2008**Project Name:** SAS Superstructure**OSM Arrival Time:** 1400**Prime Contractor:** American Bridge/Fluor Enterprises, a JV**OSM Departure Time:** 2300**Contractor:** Zhenhua Port Machinery Company, Ltd (ZPMC), Changxing Island **Location:** Shanghai, China**CWI Name:** Chen Chih-Ming**CWI Present:** Yes No**Inspected CWI report:** Yes No N/A**Rod Oven in Use:** Yes No N/A**Electrode to specification:** Yes No N/A**Weld Procedures Followed:** Yes No N/A**Qualified Welders:** Yes No N/A**Verified Joint Fit-up:** Yes No N/A**Approved Drawings:** Yes No N/A**Approved WPS:** Yes No N/A**Delayed / Cancelled:** Yes No N/A**Bridge No:** 34-0006**Component:** Corner assemblies**Summary of Items Observed:**

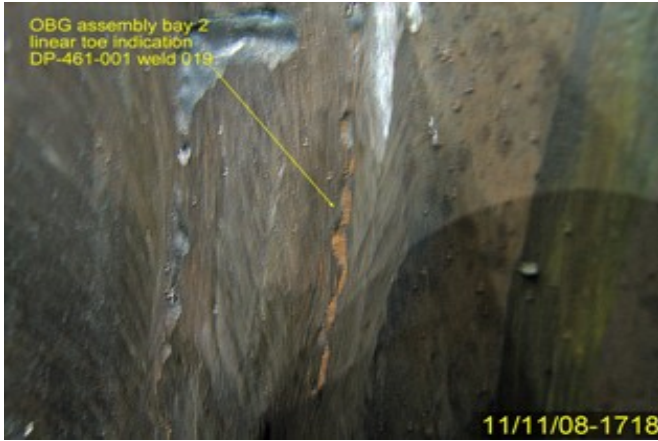
QA received ZPMC NDT notification # 001389 and performed 10% verification Magnetic particle Testing (MT) on DP-326-002, DP-461-001 and DP-488-001. QA found 3 nonconforming linear toe indications on DP-461-001 and 1 nonconforming linear toe indication on DP-326-002 (see attached photo). All welds tested on DP-488-001 appeared to be in conformance with the contract documents and AWS D1.5 2002.
